UNITED STATES ARMY AVIATION TEST BOARD  
Fort Rucker, Alabama 36362

31 MAR 65

SUBJECT: 1200-Hour Progress Report, USATECOM Project No.  
4-3-1110-06, Logistical Evaluation of the T53-L-7 Engine.

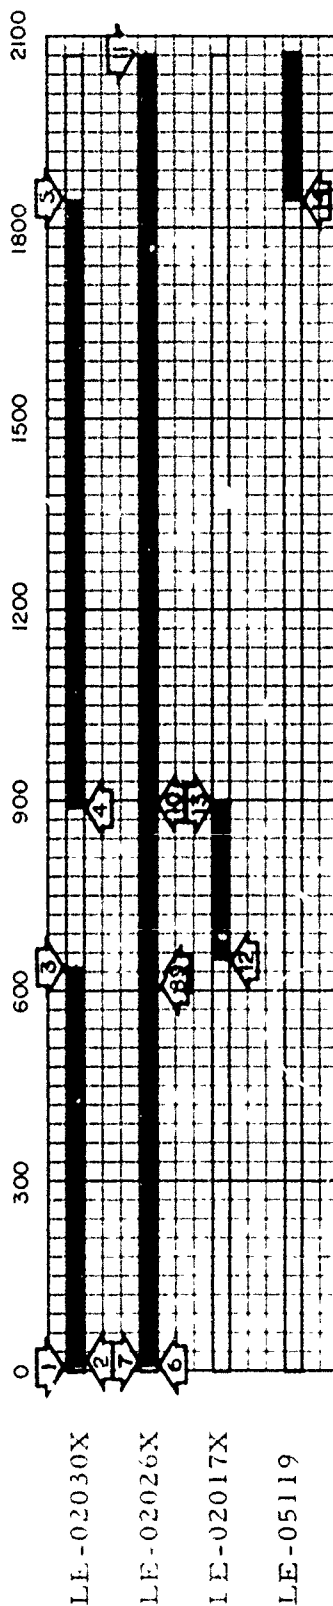
# ENGINE HISTORY

3 LE-02030X removed at 633:15 engine hours due to 5th stage compressor disc failure.

5 LE-02030X removed at 953:35 engine hours due to #3 and #4 bearing failure.

8 LE-02026X propeller shaft replaced at 596:05 engine hours.

9 LE-02026X planetary gear bearing replaced at 607:20 engine hours.
